FACILITY CONDITION ASSESSMENT

MH/MR GROUP HOME #5024

161 West Main Street

Date of Report: June 25, 2007

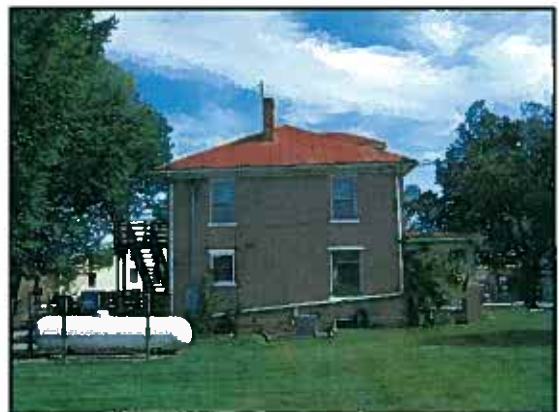
- The topography and adjacent uses do not appear to present conditions detrimental to the property.
- The landscape materials are in good condition and will require routine maintenance during the assessment period.

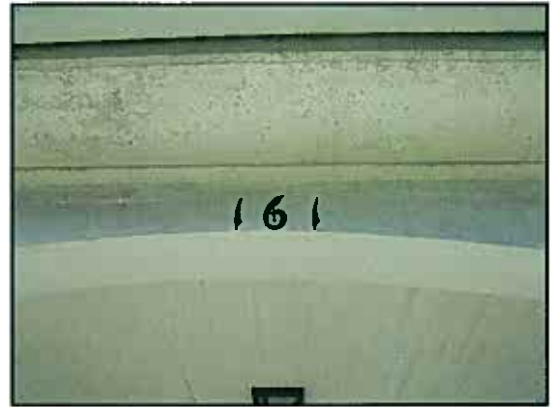
- The property address numbers are in good condition. Routine maintenance will be required during the assessment period.
- The exterior light fixtures are in good condition. Routine maintenance will be required during the assessment period.

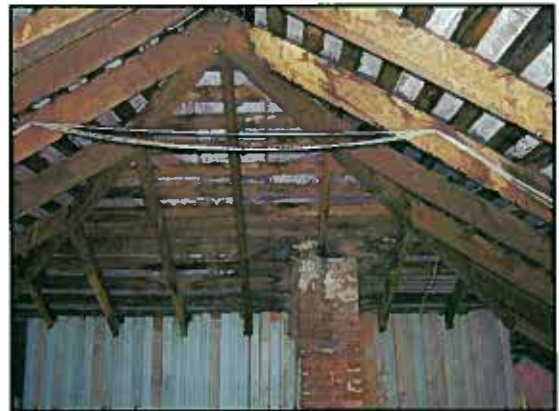
- The superstructure is exposed in some locations, which allows for limited observation. Walls and floors appear to be plumb, level, and stable. There are no significant signs of deflection or movement.

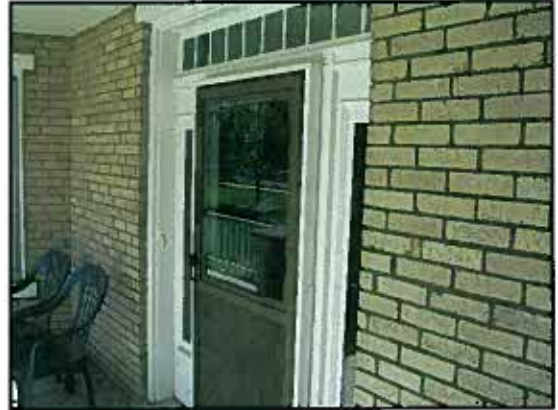
- The brick masonry veneer is in fair condition. Isolated portions of the mortar joints are cracked along the north and west elevations of the building. The brick mortar will require cleaning and re-pointing will require replacement during the evaluation period. The estimated cost of this work is included in the Deficiency Cost Table and is considered a Priority 2 corrective action.

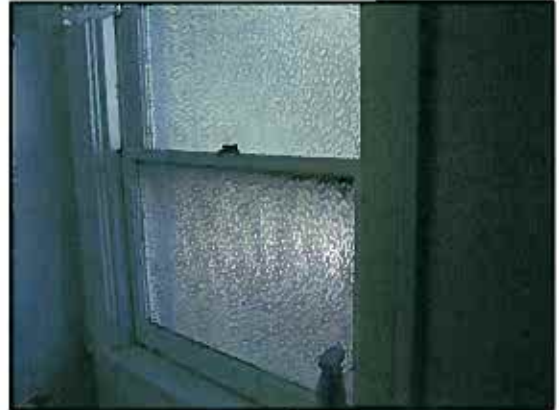
- There is evidence of window leaks and condensation. The windows are in fair condition. Based on their condition and estimated Remaining Useful Life (RUL), the windows will require painting during the assessment period. This is considered a Priority 2 corrective action, and the cost is included with the painting of the house trim in Section 6.4. Additionally, based on their estimated Remaining Useful Life, replacement during the assessment period will be required. This is considered a Priority 3 corrective action.
- The exterior doors and door hardware are in good condition and will require routine maintenance during the assessment period.

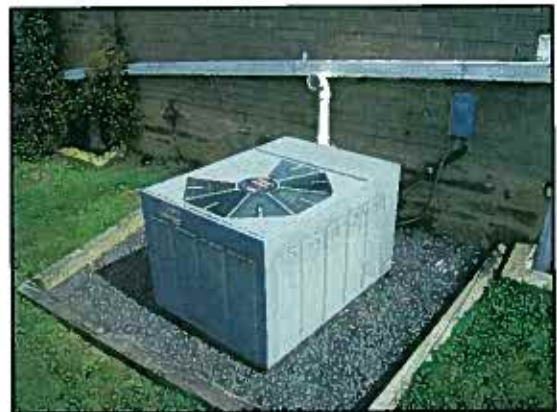
- Joe DeCarlo, HVAC Supervisor, Loudoun County Department of General Services, the property's HVAC maintenance coordinator, was contacted to discuss the history of HVAC repairs, maintenance practices, and recent replacements. Opinions from Mr. DeCarlo were solicited regarding future repair, maintenance, and replacement requirements, including the scope and cost of any necessary work. According to Mr. DeCarlo, the propane fired furnace and condensing unit were installed in 2000 and has been maintained according to manufacturer's specifications. The furnace and condenser appear to be in good condition and will require only routine maintenance during the evaluation period. However, the condenser was observed to have vibrated off of its pad. A service call by a HVAC technician is recommended as part of the property's routine maintenance program.

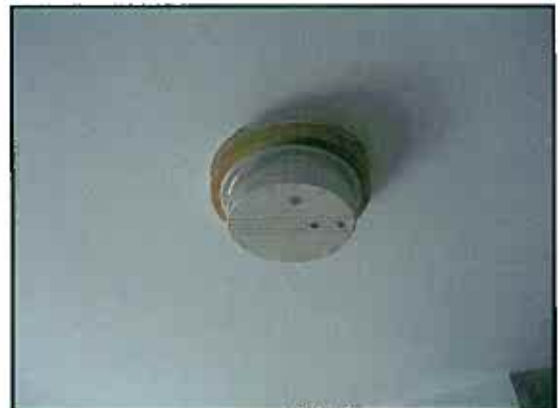
- Smoke detector replacement is considered to be routine maintenance.
- The dry chemical extinguishing systems appear to be in good condition and are serviced regularly by a qualified fire equipment contractor.

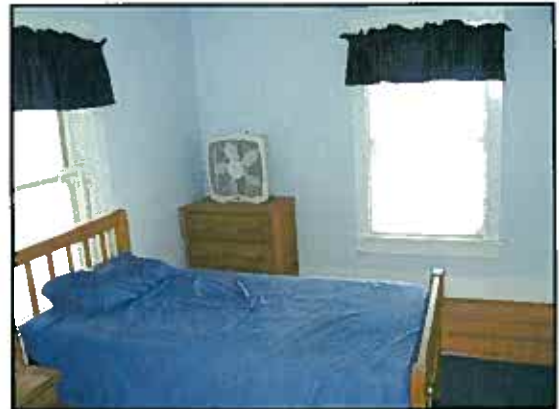
- The interior finishes in the occupant units are in good condition. the occupant areas in this building are relatively small, and the occupant areas are renovated at the same time as the common areas, the cost for the occupant area is included in Section 6.8 of this report
- The interior doors and door hardware are in good condition and will require routine maintenance during the assessment period.

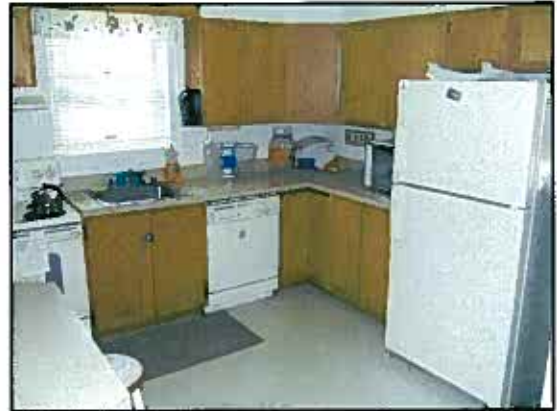
- The kitchen appliances appear to be in good condition. Based on their estimated Remaining Useful Life (RUL), some of the kitchen appliances will require replacement during the assessment period. The cost of this work is included in the Deficiency Cost Table and is considered a Priority 3 corrective action).
